Compression Response of a Sandwich Fuselage Keel Panel With and Without Damage

David M. McGowan and Damodar R. Ambur
Langley Research Center, Hampton, Virginia

February 1997

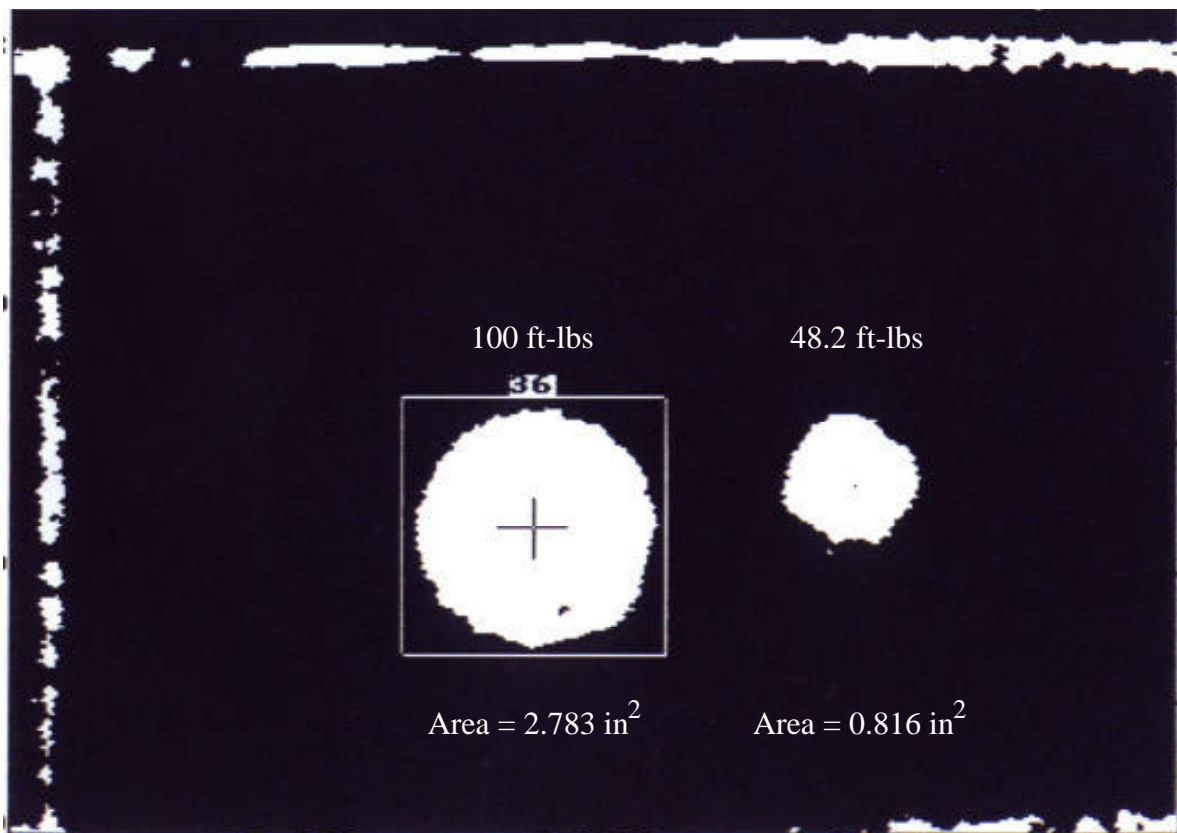
Figure 11. Ultrasonic C-scan images of impact damage at the thick end of the FK1 remnant.

of 100 ft-lbs. Although this is a very small dent, the damaged area resulting from this impact is significant. Ultrasonic C-scan images of this impact site and the 48.2 ft-lb impact site are shown in Fig. 11. As indicated in Fig. 11, the projected damage area for the 100 ft-lb impact energy is 2.789 in². Measured values of the damage area at the impact sites are plotted as a function of the impact-energy level in Fig. 12 for the thick and thin ends of the remnant. This figure is similar to Fig. 10 in that the measured values are represented by the open symbols, and cubic splines fit through these data points are represented by curves. As shown in Fig. 12, a considerable amount of damage occurs for impact energies well below 100 ft-lbs. The damage area increases as the impact-energy level is increased from 30 ft-lbs up to 100 ft-lbs. At the thin end, significant damage first occurs at 20 ft-lbs of impact energy. However, the damage area increases as the impact-energy level is increased from 20 ft-lbs to 80 ft-lbs, and it approaches a constant value for impact-energy levels greater than 80 ft-lbs. The impact-energy levels at which damage initiation is indicated in Fig. 9 is higher than the impact-energy levels for the formation of damage in the specimen. Visual inspection of the thin-end impact sites impacted at these higher impact energies showed a significant increase in surface damage. Typical shear failures across the outer $\pm 45^\circ$ plies were evident at impact energies of 90 and 100 ft-lbs. These results indicate that penetration into the laminate at the thin end was beginning to occur at impact-energy levels greater than 90 ft-lbs.

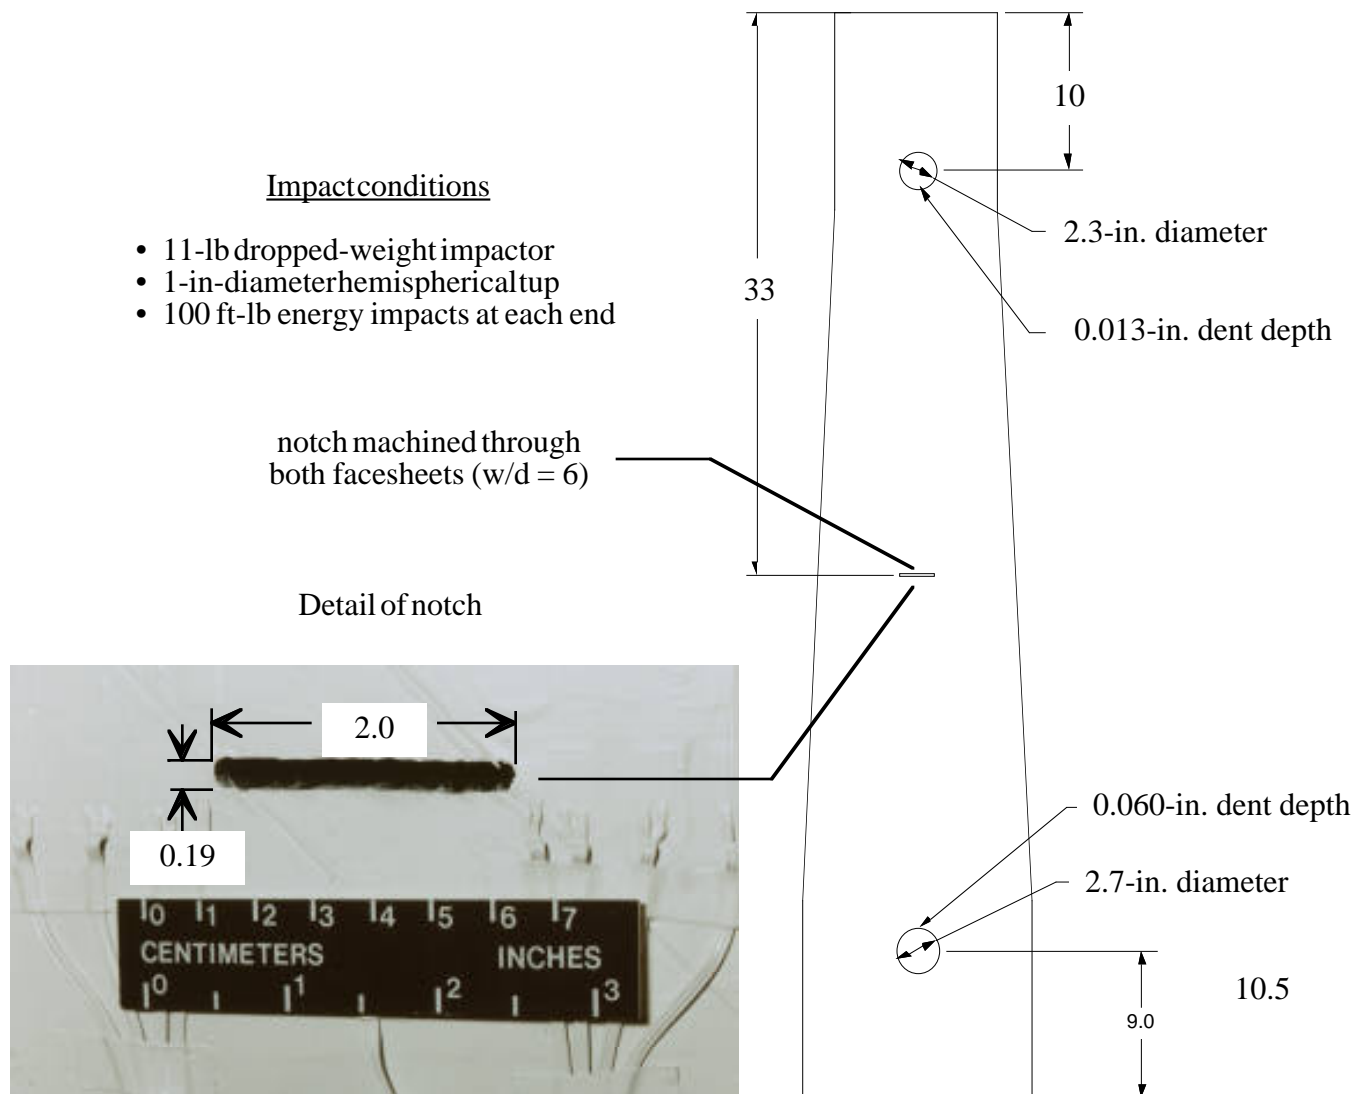
Figure 17. Details of impact-damage sites and machined notch.

Following the test of the undamaged panel, the test panel was impacted at two locations and the panel was loaded to 130 percent of its design limit load (175 kips). This load level was sufficient to provide well-defined strain distributions around the impact sites, and was low enough to prevent premature failure of the panel. As previously discussed, an impact-energy level of 100 ft-lbs was used at each impact site in an effort to inflict barely visible impact damage to the panel. The locations of the impact sites and the resulting dent depth and diameters of the damage areas are shown in Fig. 17. The impact at the thick end was 10.0 inches from the narrow end of the panel, and the impact at the thin end was 10.5 inches from the wide end of the panel. The support conditions used for these impact events matched those used for the impact-damage screening tests. Although the dent depth at the thick end is 0.013 inches, which is smaller than that obtained in the impact-damage screening tests, the dent depth at the thin end of the test panel is identical to the 0.060 inches obtained in the screening tests. The extent of the damage was mapped using a pulse-echo ultrasonic testing device. This device identifies the approximate boundaries of the damage site, and the damage-site diameters are presented in Fig. 17. As shown in the figure, the diameter of the damage site at the thick end is 2.3 inches, and the diameter at the thin end is 2.7 inches.

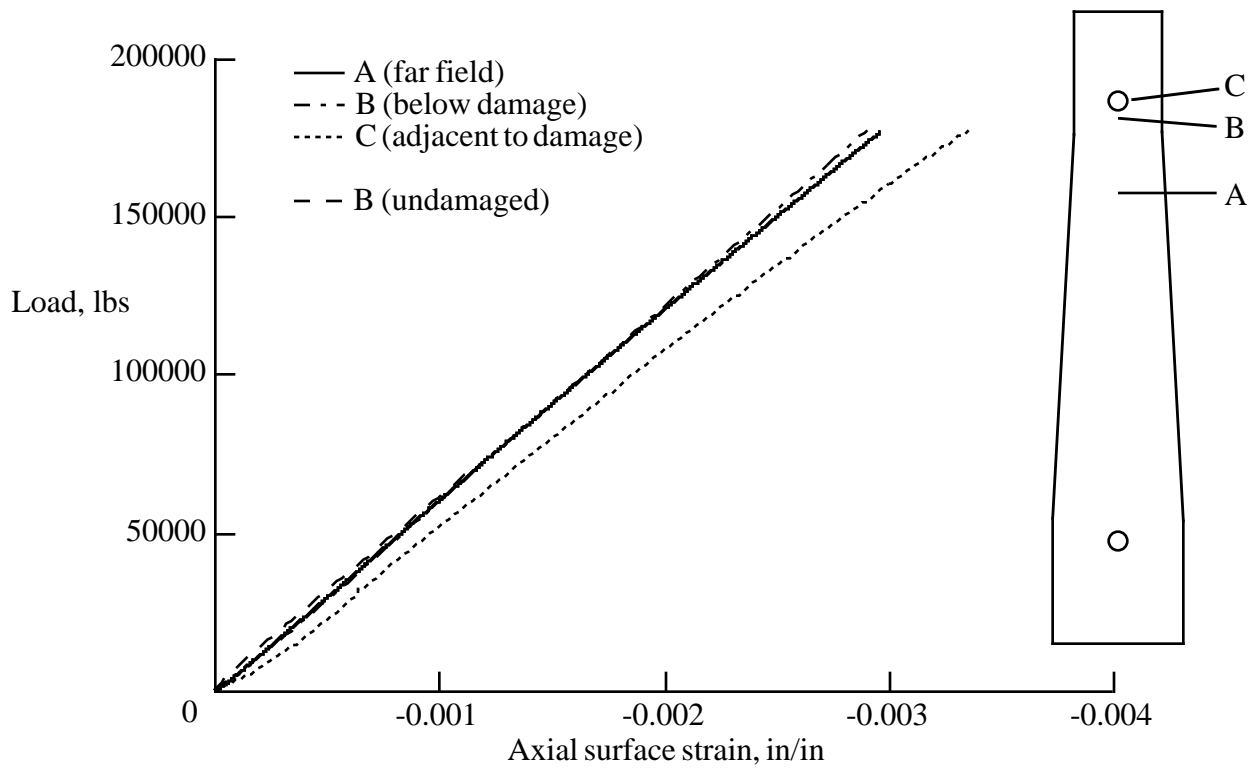
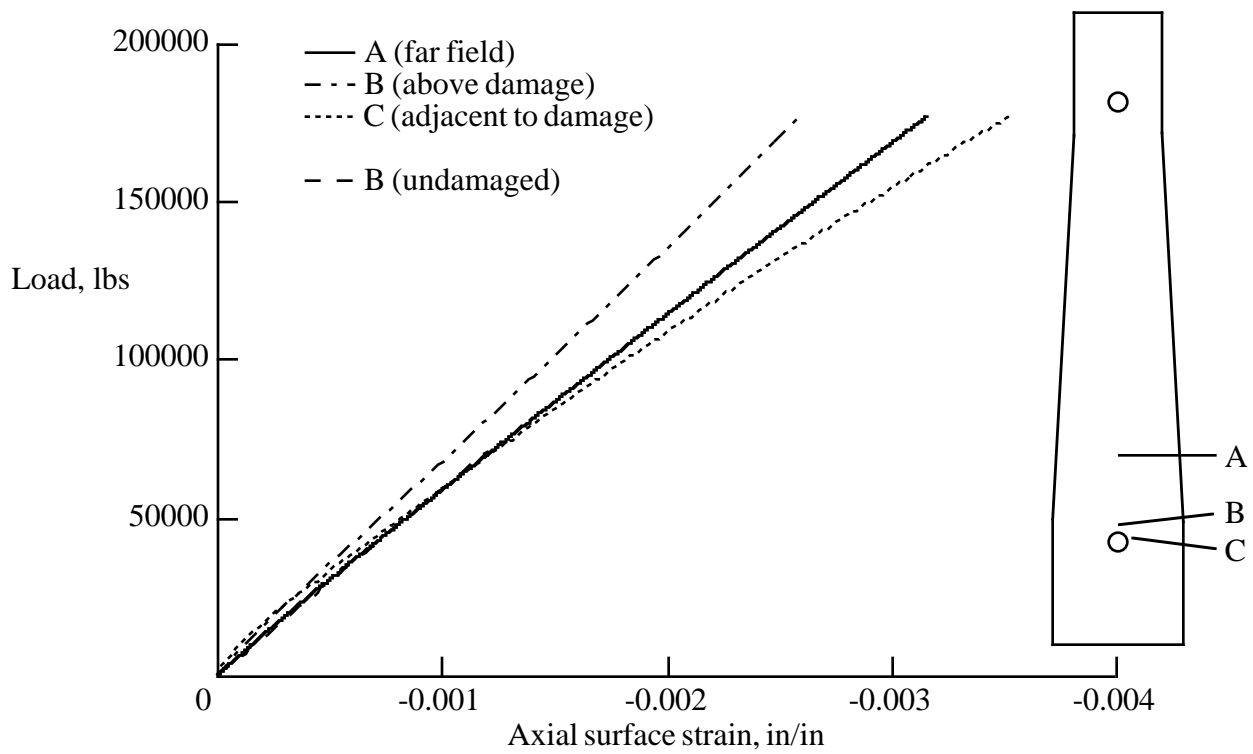
Figure 18. Experimental surface strain results for the impact-damaged panel.

each case to avoid any influence from the potted ends. Location C is adjacent to the damage sites and is located on the horizontal centerline of each site. The strain data recorded for location B during the test of the undamaged panel are also presented in each figure. The data in Fig. 18(a) indicate that the thick-end impact damage does not significantly affect the response of the panel in that region since the data for locations A and B are very similar. Furthermore, the data at location B for the undamaged-panel test are nearly identical to the data for the impacted-panel test at that location. At location C, the strain is approximately 17 percent greater than the strain at location A. These results suggest that damage at this site introduces a mild local stress concentration, but does not affect the stress state slightly removed from the damage site. The data in Fig. 18(b) indicate that the thin-end impact damage does have an appreciable effect on the response of the panel in that region. The strains at location A are approximately 19 percent greater than the strains at location B. This difference in strains directly represents the effect of the impact damage on the response of the panel since the data from location B for the undamaged-panel test is very nearly the same as those for location A for the impact-damaged panel test. The strains at location A are approximately 16 percent lower than those at location C. The results presented in these figures confirm the intuitive notion that the larger damage site at the thin end of the panel affects the response more than the damage at the thick end.

Experimental results from the test of the impacted panel show that the impact damage at the thin end of the panel is more critical than that at the thick end. The diameter of the impact-damage site at the thin end is larger than that at the thick end. Experimental surface strain results that show the local strain distribution around each impact-damage site indicate that the strain gradients around the site at the thin end of the panel were larger than those around the site at the thick end of the panel.

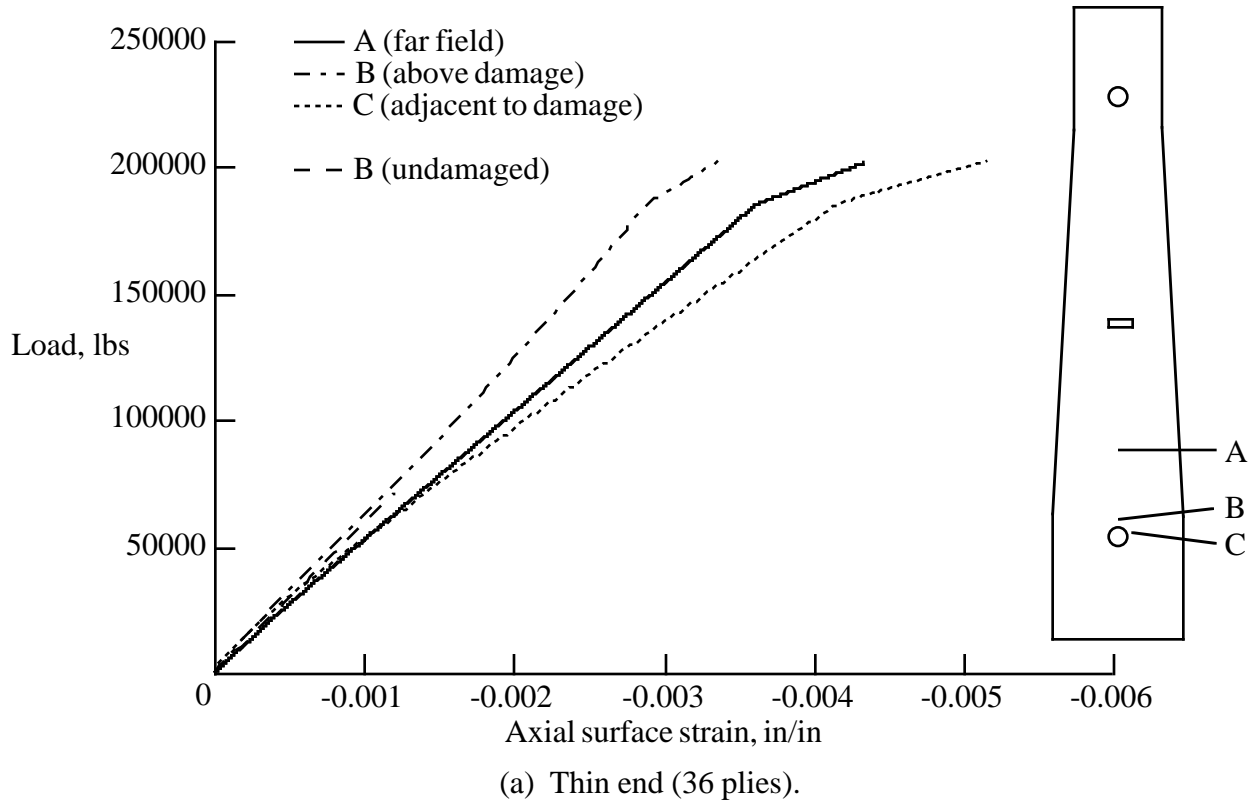
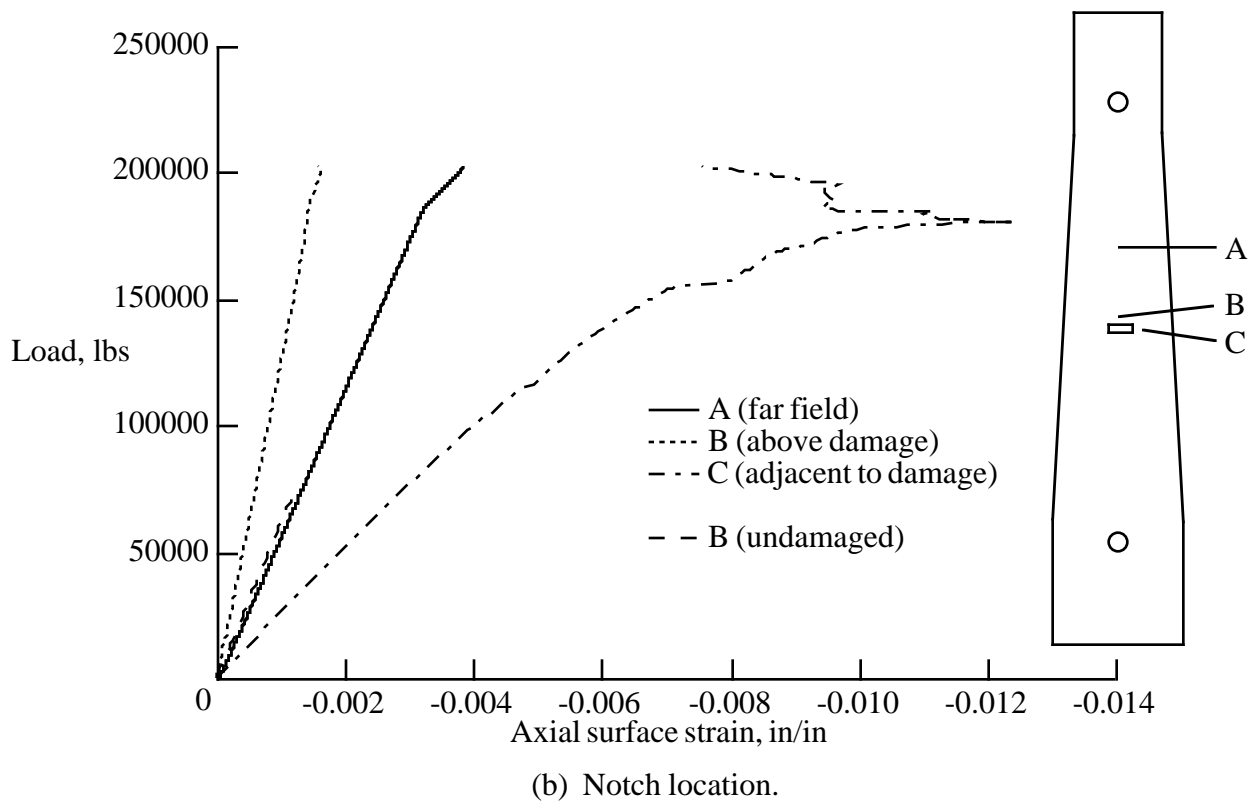
Figure 19. Experimental surface strain results for the notched panel.

Experimental surface strain results for the notched panel that show the strain distributions around the impact site at the thin end of the panel are given in Fig. 19(a). The trends in the data are very similar to those shown in Fig. 18(b). The strain level decreases as the damage site is approached from the far field location (from location A to B) and it increases adjacent to the damage (from location A to C). This result suggests that the notch has no influence on the load distribution at this impact site. The change in slope of the three curves in Fig. 19(a) correspond to a local failure that occurred near the notch tip. Experimental surface strain results for the notched panel showing the strain distributions around the notch are given in Fig. 19(b). The results in this figure indicate that the notch site is the most critical of the three damage sites. The compressive strain level increases by more than a factor of two when the damage site is approached from the far field location (from location A to B). More importantly, there is an increase in the strain level

of 350 percent over the far-field value at the notch tip (location C). The strain level at this point reaches a maximum of approximately 12,500 μ -in/in before local failures in the face sheets occurred at approximately 185 kips of applied load. Evidence of these local failures is indicated by the decrease in the strain level at location C for loads greater than 185 kips. This decrease in strain occurs as the load redistributes around the local failure sites at the notch tip. Analytical surface strain contours for the notched panel are presented in Fig. 20. The results in this figure are presented for an applied load of 70 kips. As shown in Fig. 20, the analysis predicts a relatively uniform strain distribution in the areas of the panel that are not near the notch location. There are, however, very high strain gradients predicted near the notch. An enlarged view of the notch location that shows these gradients is also given in Fig. 20. Experimental strain values at locations above and adjacent to the notch are also given in this figure. Although the predicted strain above the notch is close to the experimental value, the predicted strain at the notch tip is higher than the experimental value. This difference can be attributed to the coarseness of the finite element mesh at this high stress gradient region.

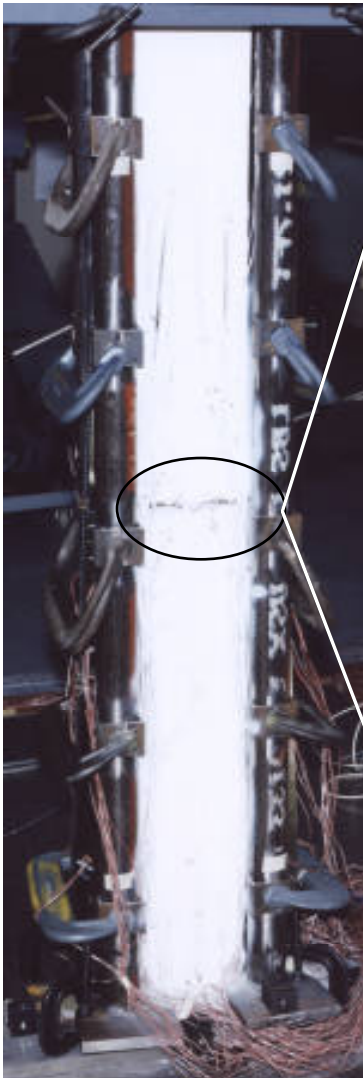
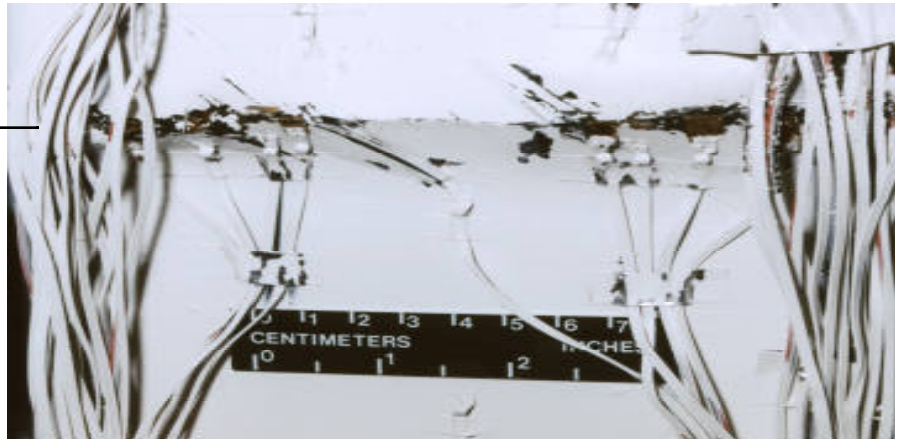
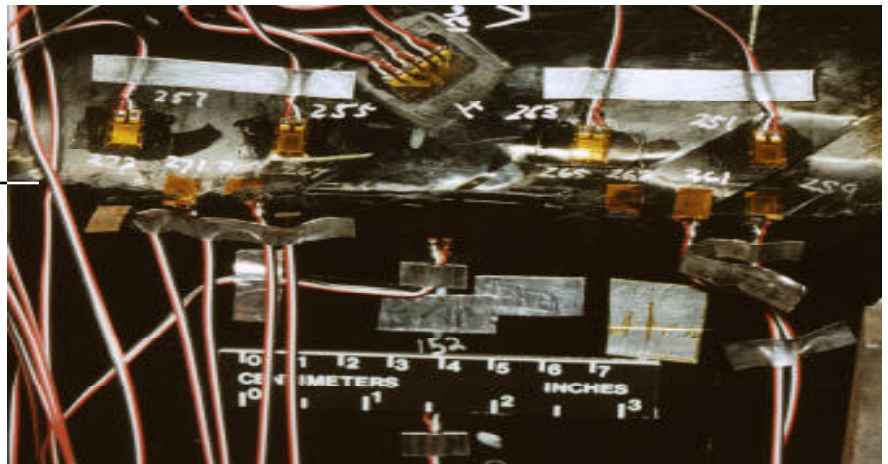
Figure 21. Failure mode for the notched panel, failure load = 202 kips.

Failure occurred across the width of the panel at 202 kips which is the design ultimate load of the panel. The failure mode of the panel is shown in Fig. 21. The failure mode is a compression failure of both face sheets at the notch location. Photographs showing front and back views of the failure are shown in Fig. 21. A post-test ultrasonic inspection of the two impact sites indicated that the area of the impact damage did not grow during the final two tests.

Experimental and analytical results for the test of the notched panel identify the notch site as being the most critical damage site. Surface strains that were 350 percent larger than far field strains occurred at the notch tip. The compression strains at a location near the notch location increase by over a factor of two compared to the far field value. The notch tip was also the site of a local failure that occurred prior to failure of the panel. A panel failure occurred across the width of the panel at a load equal to 100 percent of the design ultimate load for the panel. The mode of failure was a compression failure of both face sheets at the
